Service Information bulletin	Number 4	
date	16-11-2007	
product	Ride On	
subject	Collision Gas spring	
Serial numbers	500 - 799

Collision between ball joint from gas spring and fixation mushroom at all models:

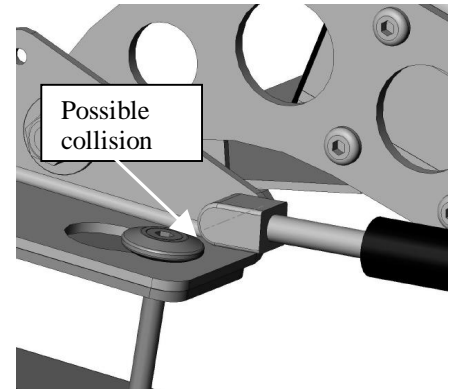
The ramps in this batch have fitted gas springs from a different supplier. This caused a possible small collision between the ball joint from the gas spring and the fixation mushroom.
